# **LABORATORY REPORT ON**

**Airborne Sound Transmission-Loss  
Measurement of**

**The Gypsum Board - Sandwich Panel  
with Door Set**

## STC 43 - Wall Sound Test With Door Installation

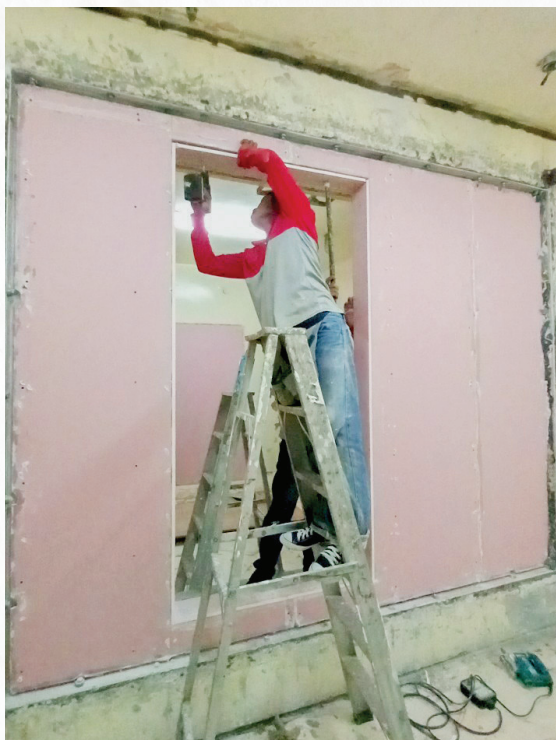
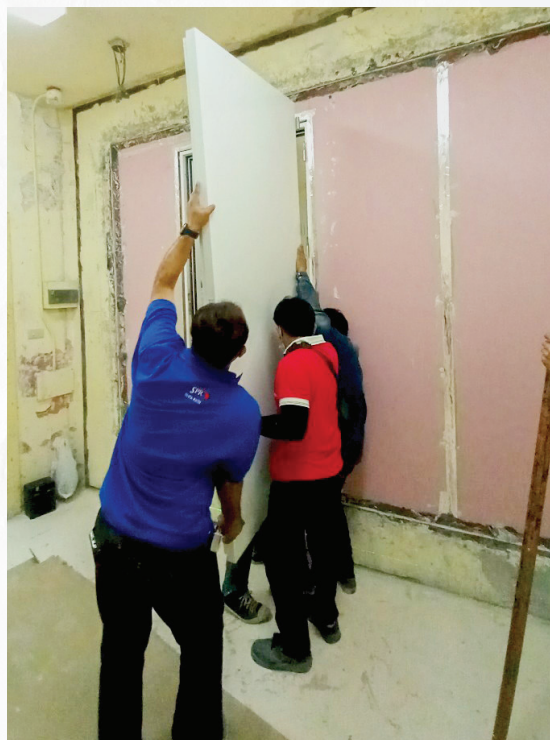
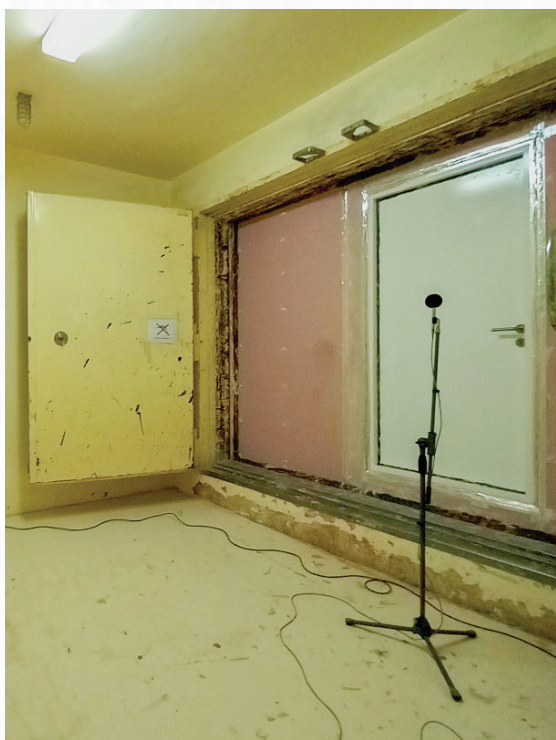
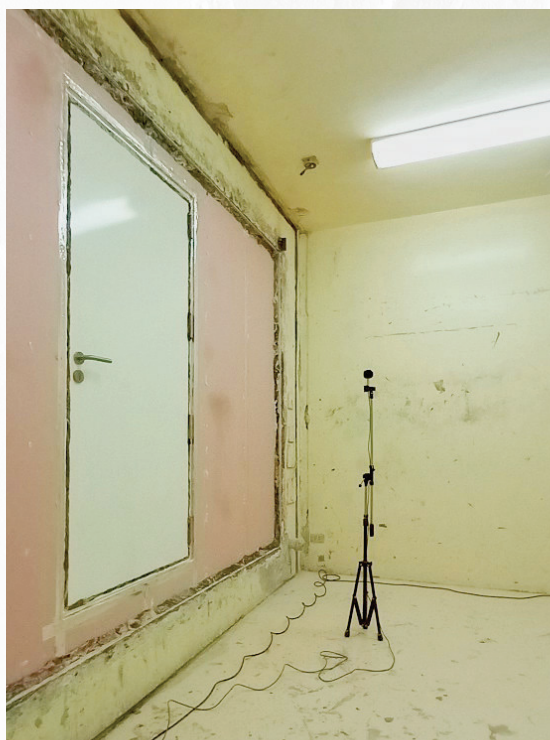
## SPECIFICATION

**Test panel:** *RICCO* sandwich panel (100 mm. thickness) and *FireBloc* Gypsum board (15 mm. thickness) with *SAC 01 C42* door set.

**Test sample size:** 3040mm. x 2440mm.
